# **INDOOR AIR QUALITY ASSESSMENT**

**Bristol County 3<sup>rd</sup> District Court  
75 North Sixth Street  
New Bedford, Massachusetts**

Prepared by:  
Massachusetts Department of Public Health  
Bureau of Environmental Health Assessment  
July, 2000

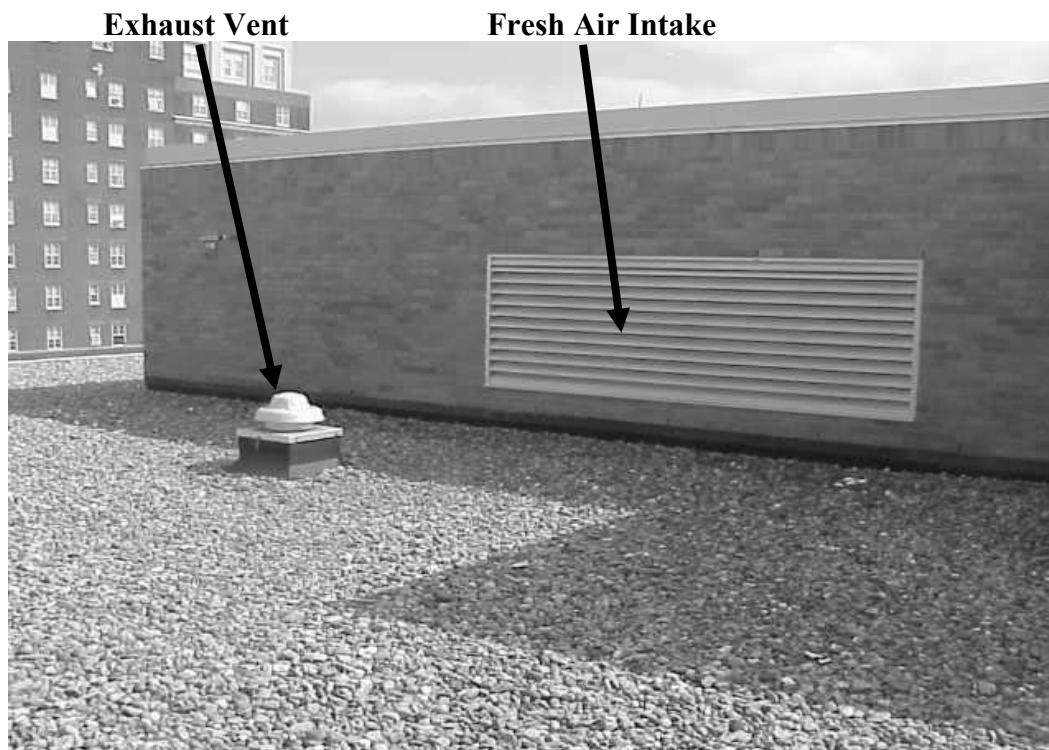
**Picture 1**

Exhaust ventilation motors on the roof were designed to provide local exhaust for restrooms or kitchens only. The blueprints also confirm that all of the rooftop exhaust motors (see Picture 1 for an example) serve as local exhaust vents only (see Appendix B) (SBRAA, 1981b). During both assessments, over half of the local exhaust vent motors were deactivated, indicating either the motors were burned out or disconnected from a power source. Without functioning exhaust ventilation, moisture and restroom/kitchen odors will tend to linger within the building.

**Exhaust Vent Fan on Roof, Note Close Proximity to Fresh Air Intake of AHUs**

- d) Seal holes around utility pipes in the ceiling of the garage. Render wall seams or other breaches in the walls and ceiling airtight.
- 2) Activate exhaust vent motors and operate during business hours. If exhaust vent motors are broken, repair.

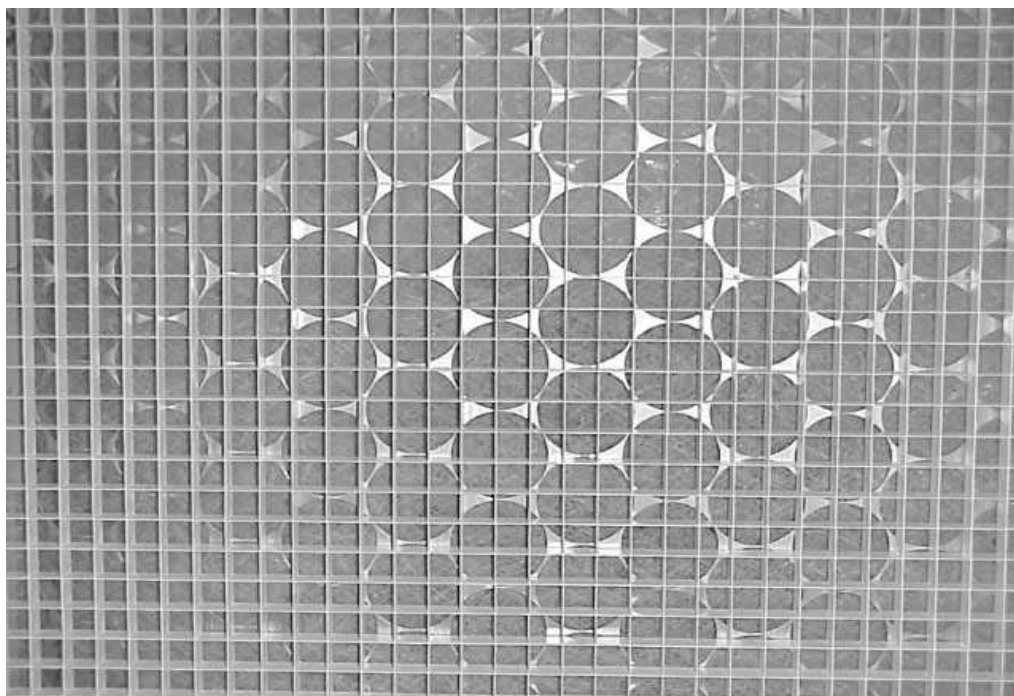
**Picture 2**

A former storeroom was converted into a courtroom (Courtroom #5). In order to provide ventilation to this courtroom, new ductwork was cut into the existing HVAC system to provide fresh air. The addition of this courtroom should have required an increase in air flow velocity for the AHU servicing the basement in order to compensate for added ductwork. If the airflow velocity of this AHU was not increased after the installation of the ductwork in the basement, the ability of this equipment to provide other offices in the basement with adequate airflow would have been degraded. Decreasing the ability of the fresh air diffusers was the installation of filters within the duct (see Picture 2). The usual practice is to provide filtration within the AHU itself. By having the filters located at the air diffusers at a point farthest from the AHU, the filters can serve to prevent airflow into the new courtroom.

**Filter Installed Inside of Return Vent in Courtroom #5**

- 9) Remove electrical power source to heater above ceiling of courtroom #5.
- 10) Remove filters from the return air vents of court room #5.
- 11) Deactivate the heater in the ceiling of courtroom #5. Prevent chilled water from filling the coil of this unit to prevent the generation of condensation.

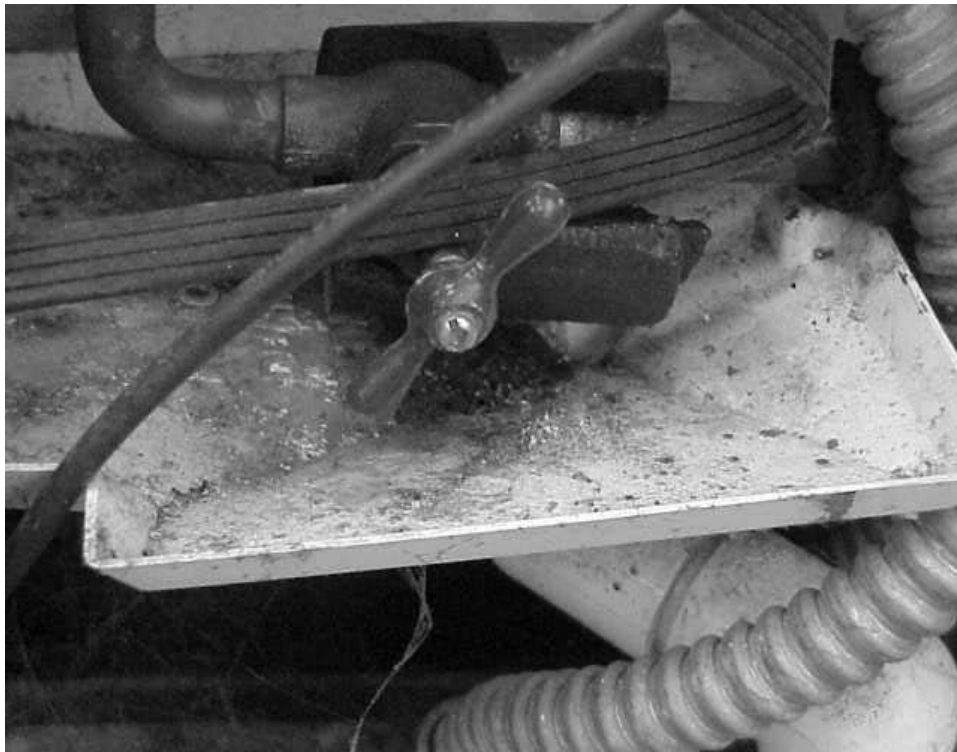
**Picture 3**

Fan coil units provide both heating and air-conditioning. Each FCU has drip pans to collect and drain condensation from cooling coils. Several FCUs were examined. Each coil examined was observed to have a build up of dirt and other debris (see Picture 3), which can serve as a growth medium for mold when these units are activated for air conditioning.

**Drip Pan in FCU Caked with Debris**

- 15) Disinfect the drip pans in FCUs with an appropriate antimicrobial agent and clean debris from drip pans.
- 16) Consider placing a water impermeable barrier beneath water cooler to prevent moistening of carpet.

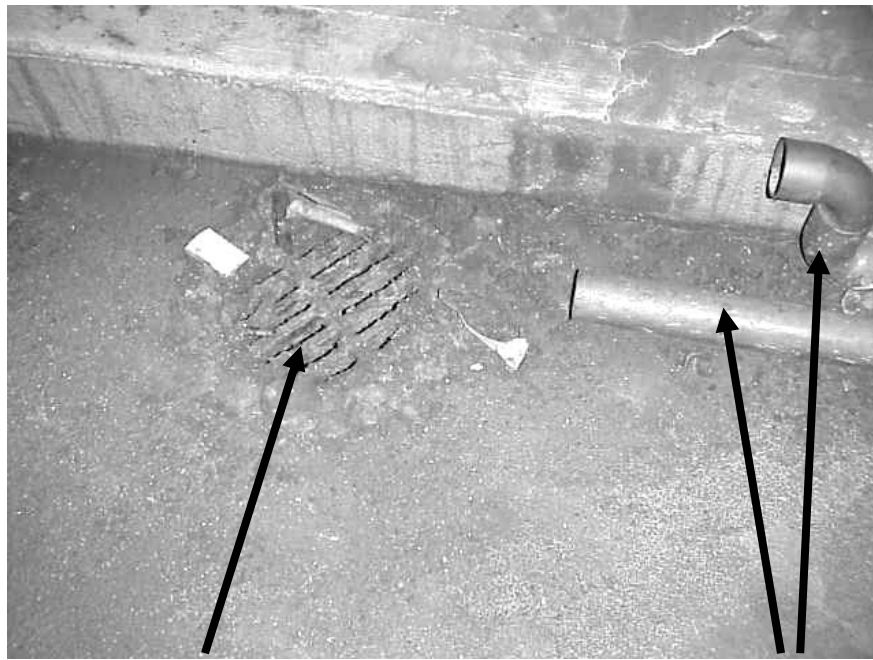
**Picture 4**

drawing air into each unit through the condensation drains. This condition occurs because no water is produced by the AHUs to create a watertight seal in the condensation drain. With each condensation drain acting as a vacuum, odors from the floor drain can be drawn into the AHUs and be distributed to occupied areas in the building.

**Floor Drain**

**AHU Condensation  
Drains**

**AHU Drainpipes That Terminate over Floor Drain**

- a) Seal the floor drain in the garage.
  - b) Ensure water is poured into the AHU floor drains every other day to maintain the integrity of the traps.

- c) Seal the condensation drains for AHUs during the heating season. Please note that these drains must be unsealed during the air-conditioning season in order to drain condensation. Failure to remove condensation drain seals can result in water back up into AHUs and produce mold growth.

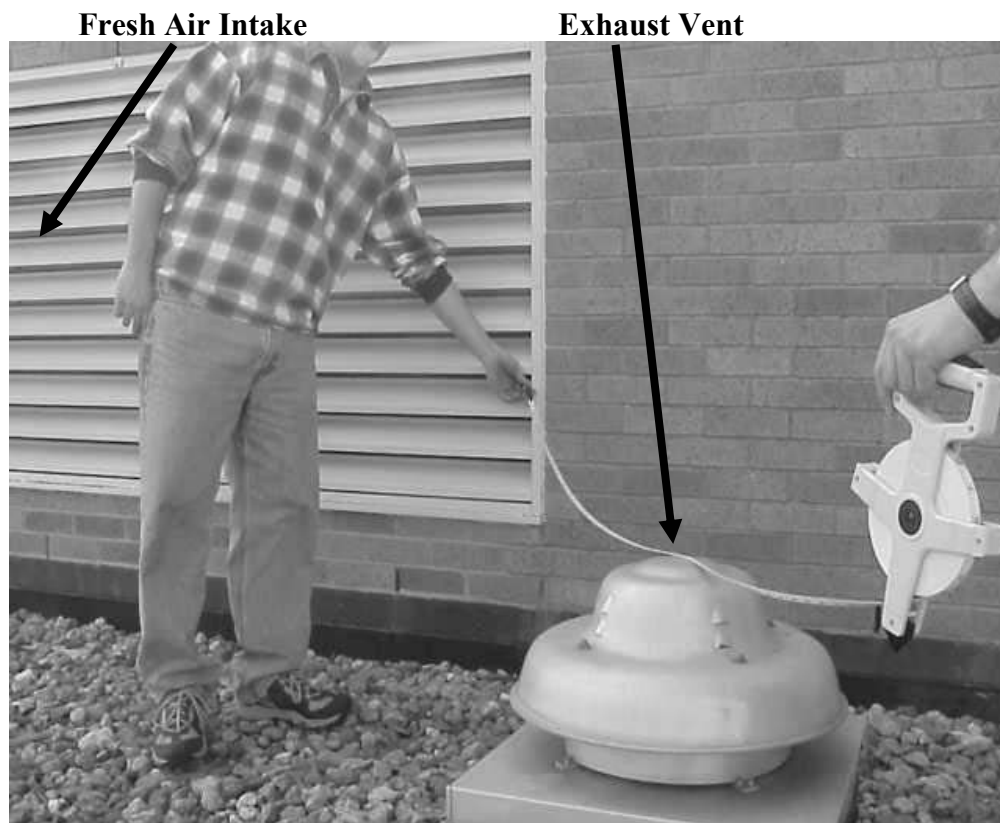
**Picture 5**

Other sources of odors in the building may be attributed to the placement of exhaust vent motors on the roof. The air intakes for AHUs are located on the east wall of the attic. This allows for the entrainment of exhaust air into the supply system. This phenomenon is known as “short-circuiting”. Short-circuiting can also be responsible for odors reported in the building.

**Exhaust Vent within 3 feet of AHU Fresh Air Intake**

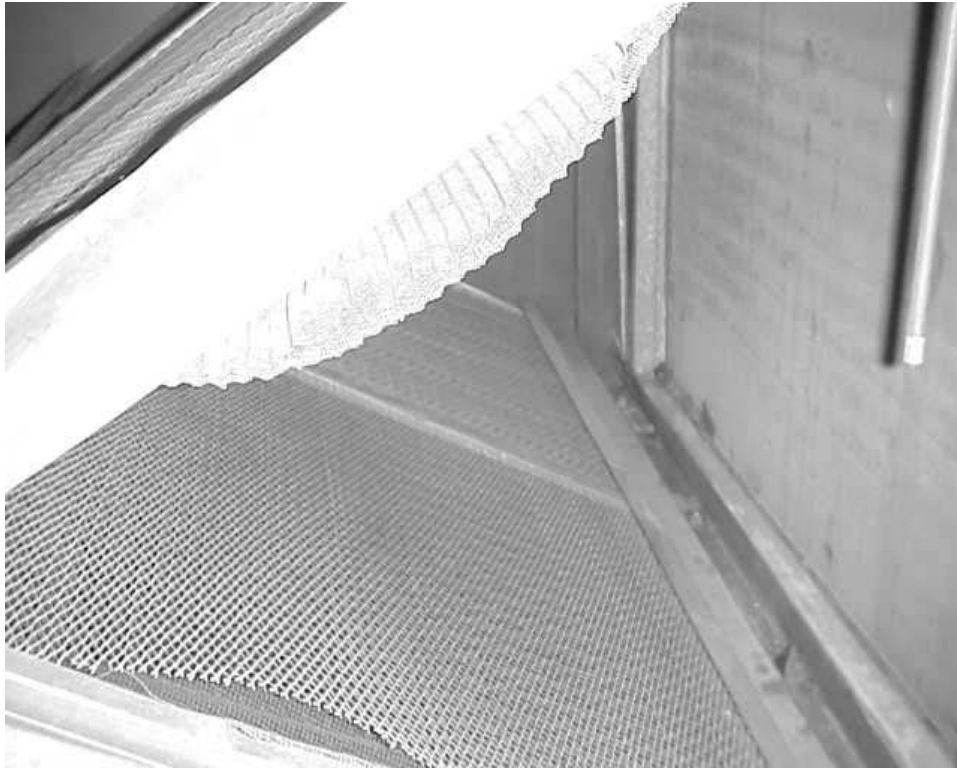
**Picture 6**

The AHUs are equipped with wire mesh screens (see Picture 6). These wire mesh screens are designed to prevent large objects from entering the AHU chamber and fans. These wire mesh screens do not filter respirable dusts from the air stream. This can result in dust, dirt and other debris being distributed by the ventilation system. AHUs are usually equipped with filters that strain particulates from airflow. In order to decrease aerosolized particulates, disposable filters with increased dust spot efficiency can be installed in the AHUs. The dust spot efficiency is the ability of a filter to remove particulates of a certain diameter from air passing through the filter. Filters that have been determined by ASHRAE to meet its standard for a dust spot efficiency of a minimum of 40 percent would be sufficient to reduce airborne particulates (MEHRC, 1997; ASHRAE, 1992). Note that increased filtration can reduce airflow produced

**Wire Mesh Screens in AHU**

through increased resistance. Prior to any increase of filtration, each AHU should be evaluated by a ventilation engineer to ascertain whether it can maintain function with more efficient filters.

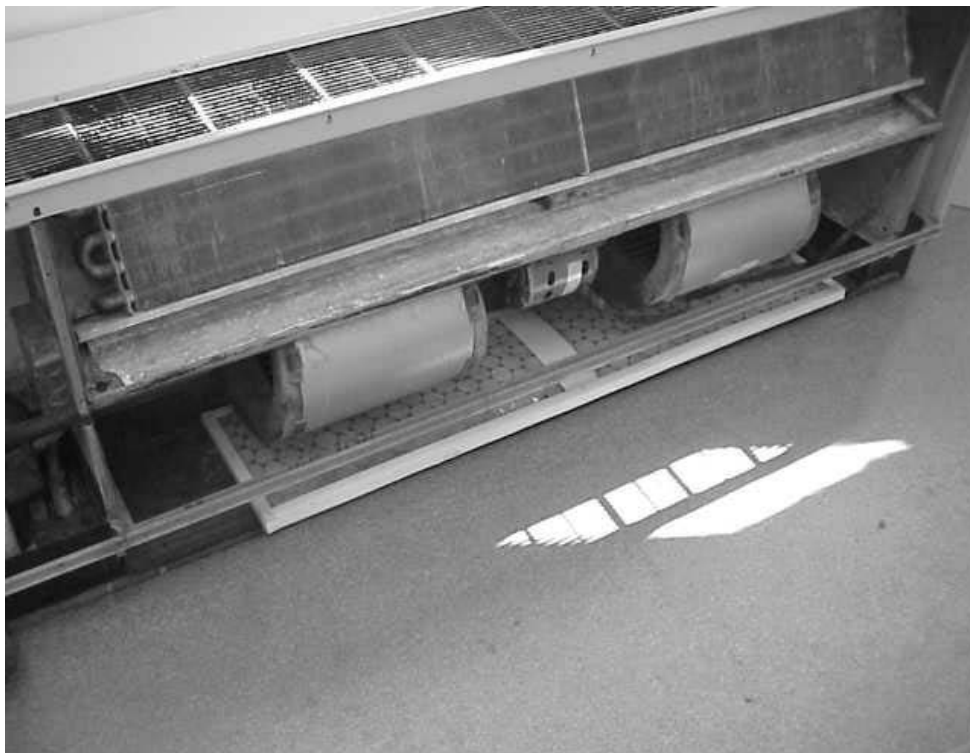
**Picture 7**

A number of fan coil units were found without air filters. Some air filters were placed on the floor of the FCU cabinet and not in the filter rack (see Picture 7). In addition, some FCU air filters were undersized. Filters should be sized properly to fit flush with the filter rack. If not sized properly, air drawn into the FCU can bypass filters through spaces between filters and racks, resulting in dust, dirt and other debris to be distributed by the ventilation system.

**Filter Placed on Floor of FCU Cabinet**

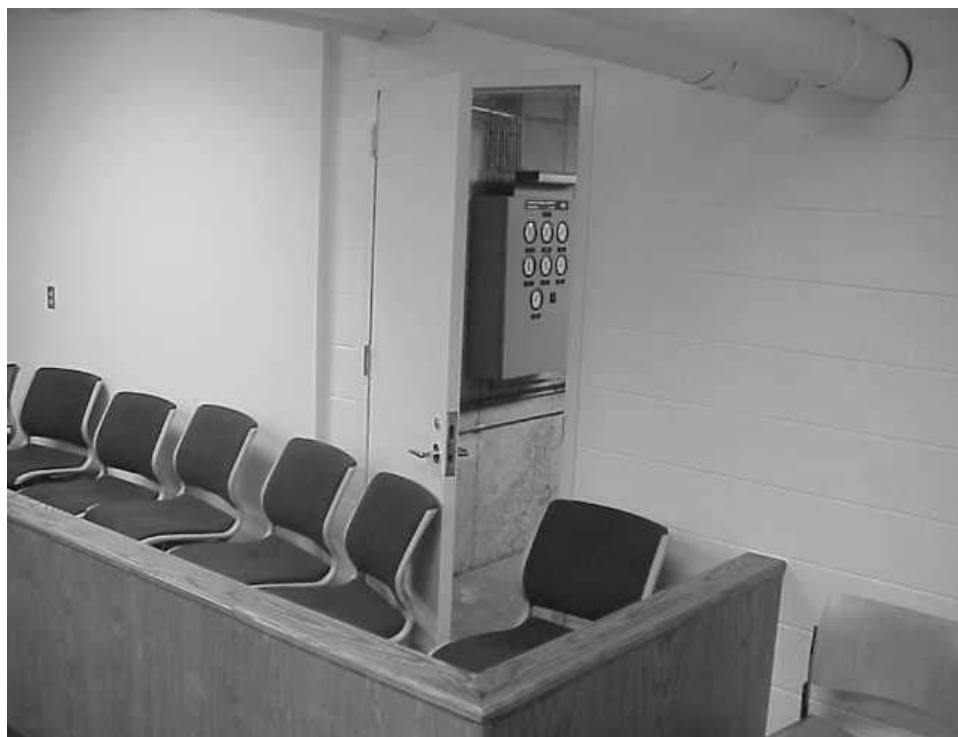
**Picture 8**

Several conditions in court room #5 can have a negative impact on indoor air quality. The room is located next to the boiler room, sharing an adjoining door (see Picture 8). In order to prevent boiler room odors from penetrating into the room, this door should remain closed and sealed with weather-stripping. A suspended ceiling was installed in this room. Above this ceiling is a fan heater that is connected to the building heating system (see Picture 9). This heater was *operating*, resulting in hot air being pumped into the ceiling plenum. The heater appeared to be controlled by a thermostat in this room that is independent from the rest of the HVAC system. Since the building is air conditioned, chilled water would be expected to enter the coil pipe. This condition may result in the creation of condensation, which can wet ceiling tiles and lead to mold growth. The unit appears to have generated condensation in the past, as evidenced by the rust on the outside of the uninsulated pipe leading into the fan unit (see Picture 10). This heater should be deactivated, since its function was rendered redundant by the installation of the ventilation system and suspended ceiling.

**Door Leading to Furnace Room from Courtroom #5**

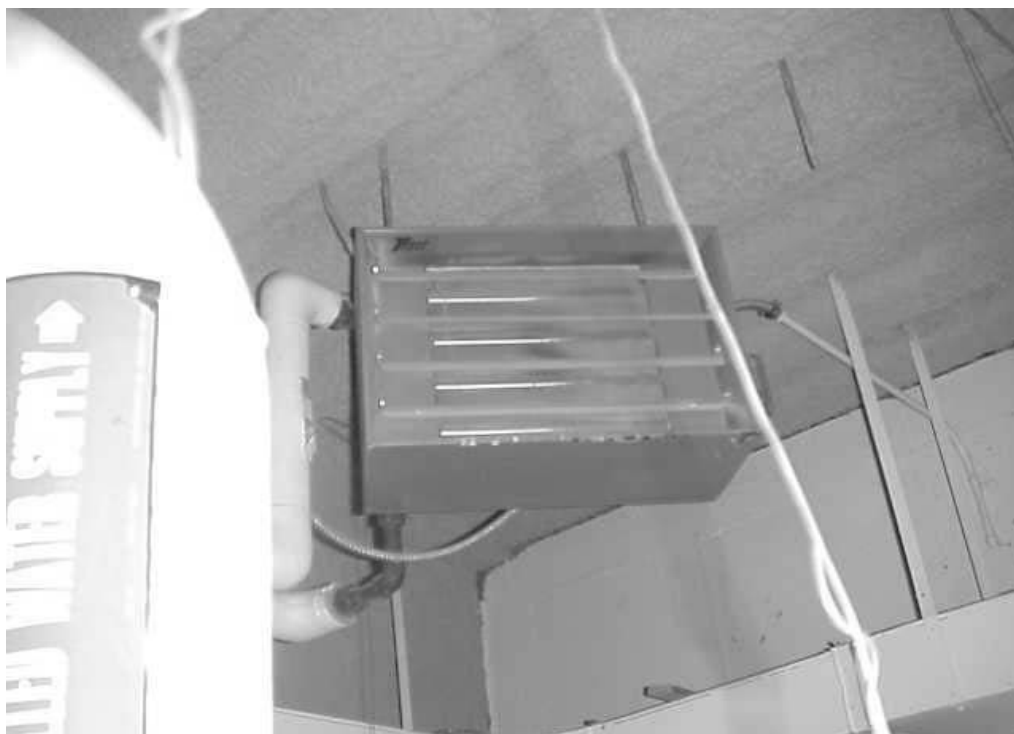
**Picture 9**

**Fan Heater above Ceiling of Courtroom #5**

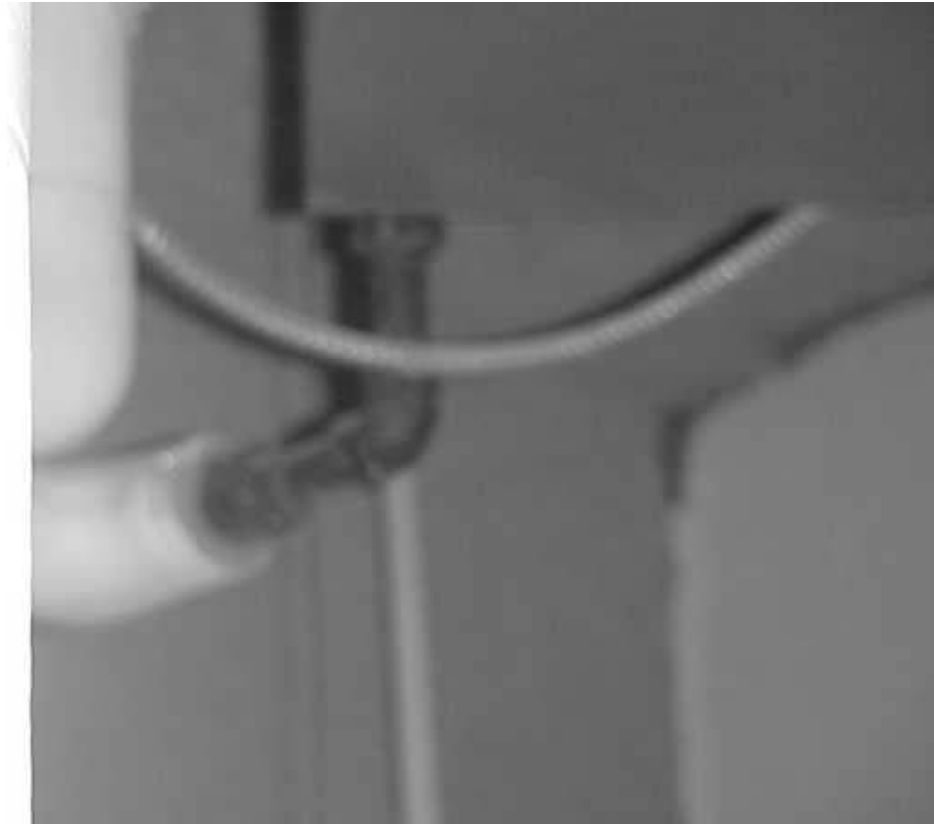
**Picture 10**

**Close Up of Corroded Pipe of Heater above Ceiling of Courtroom #5**

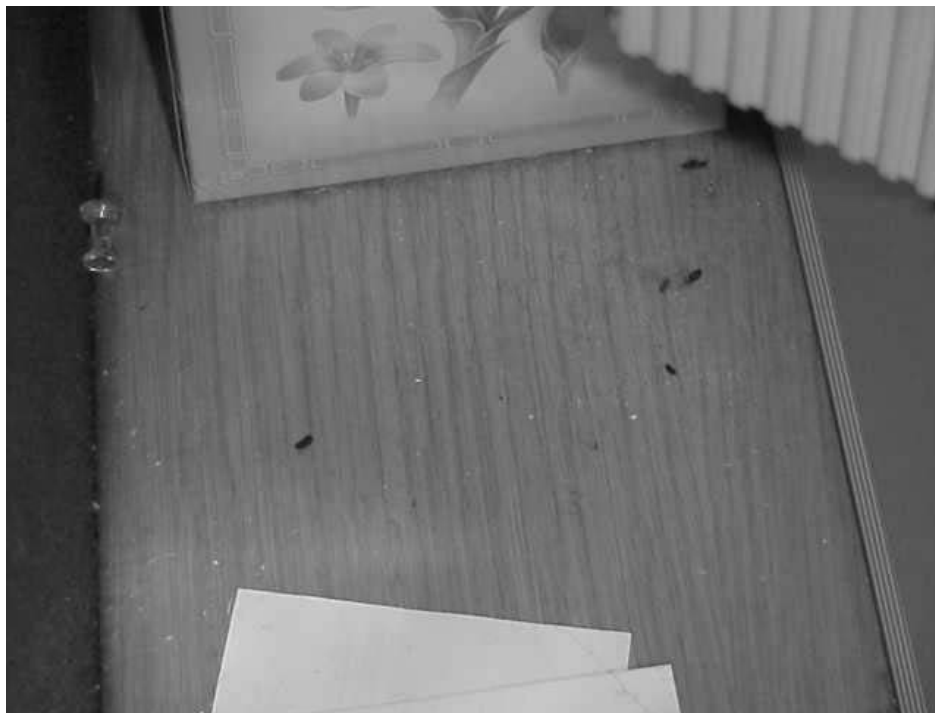
**Picture 11**

The building shows signs of rodent infestation. Mouse wastes were noted behind computers on desks in the clerk's office, behind floor dividers and inside of FCU cases (see Pictures 11, 12, and 13). In addition, several materials showed signs that rodents were present (see Picture 14). Rodent infestation can result in indoor air quality related symptoms due to materials in their wastes. Mouse urine contains a protein that is a known sensitizer (US EPA, 1992). Of particular note was the presence of rodent wastes in the interior of FCU cases. FCUs without filters can draw particulate materials into the air stream, and distribute these materials into occupied areas. It is important that proper filters be installed in FCUs to avoid this problem. A three step approach is necessary to eliminate rodent infestation:

**Rodent Droppings on Desk in Clerk's Office**

- 17) Rodent droppings should be cleaned from all work areas as well as the interior of each FCU. This may require the moving of equipment and office dividers to clean inaccessible areas. The use of a high efficiency particulate arrestance (HEPA) filter equipped vacuum cleaner is recommended to avoid aerosolization of rodent related allergens. Wet extraction cleaning of carpets may be necessary.

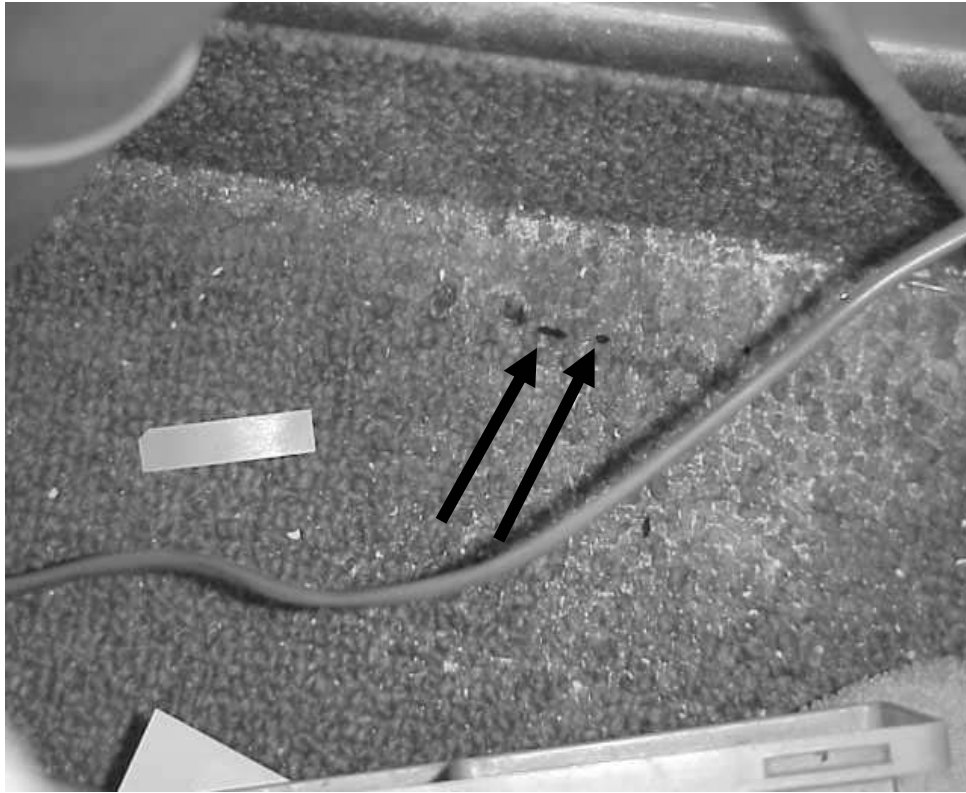
**Picture 12**

**Rodent Droppings on Carpet of Clerk's Office**

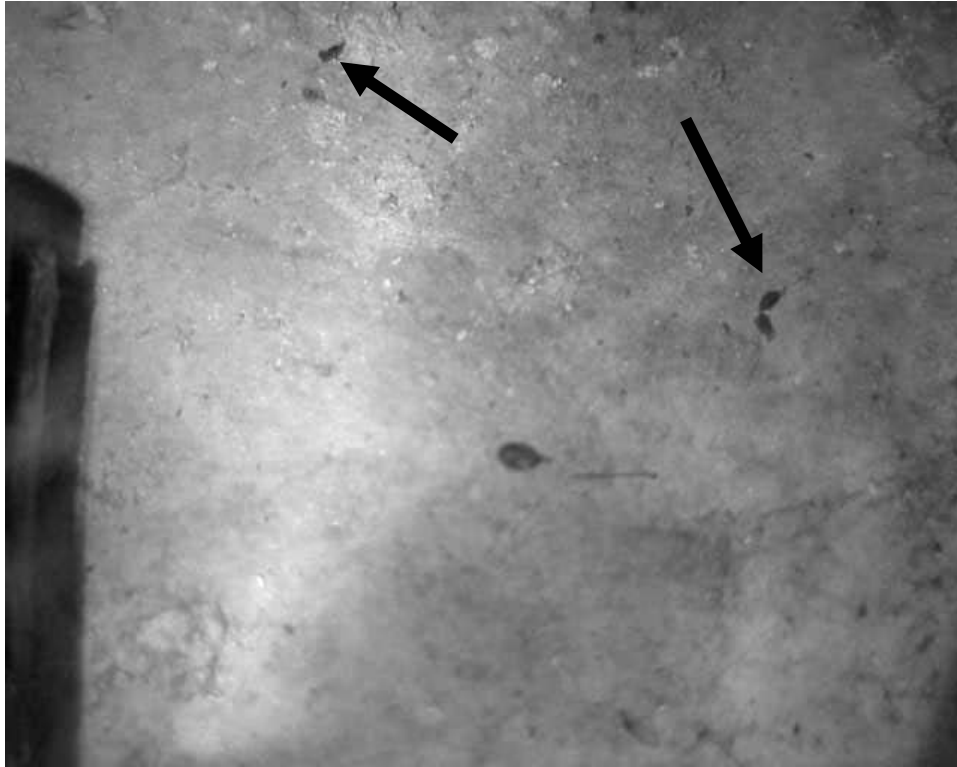
**Picture 13**

**Rodent Droppings inside FCU Cabinet in Courtroom #4**

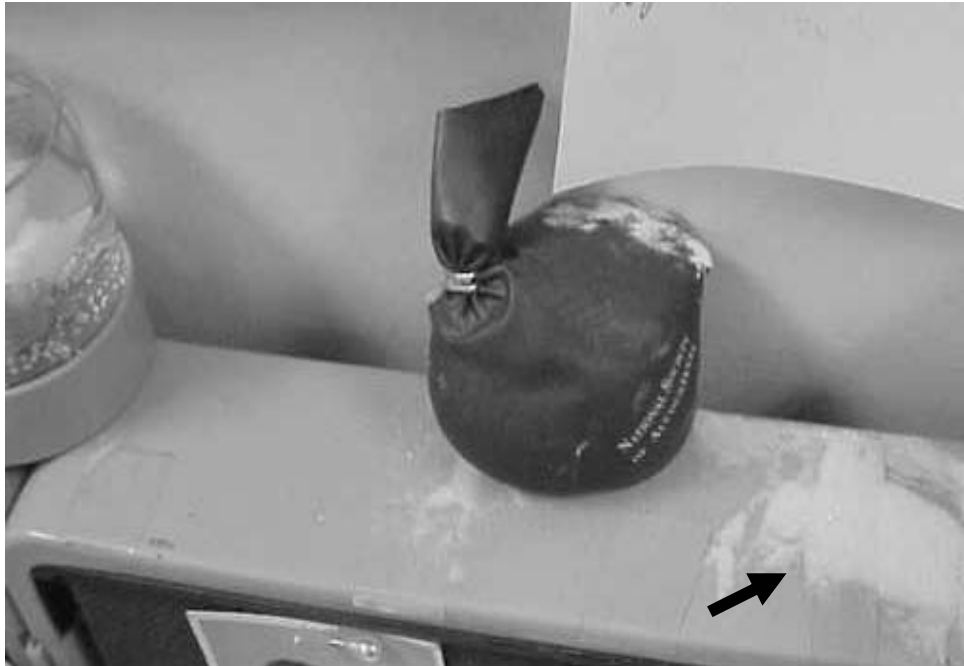
**Picture 14**

**Item Purported Masticated by Rodents, Note Sack Filling on Flat Surface**

- 18) It is highly recommended that the principles of integrated pest management (IPM) be used to rid this building of pest. A copy of the Massachusetts IPM recommendations are included with this report as [Appendix E](#) (MDFA, 1996). Activities that can be used to eliminate pest infestation may include the following activities.

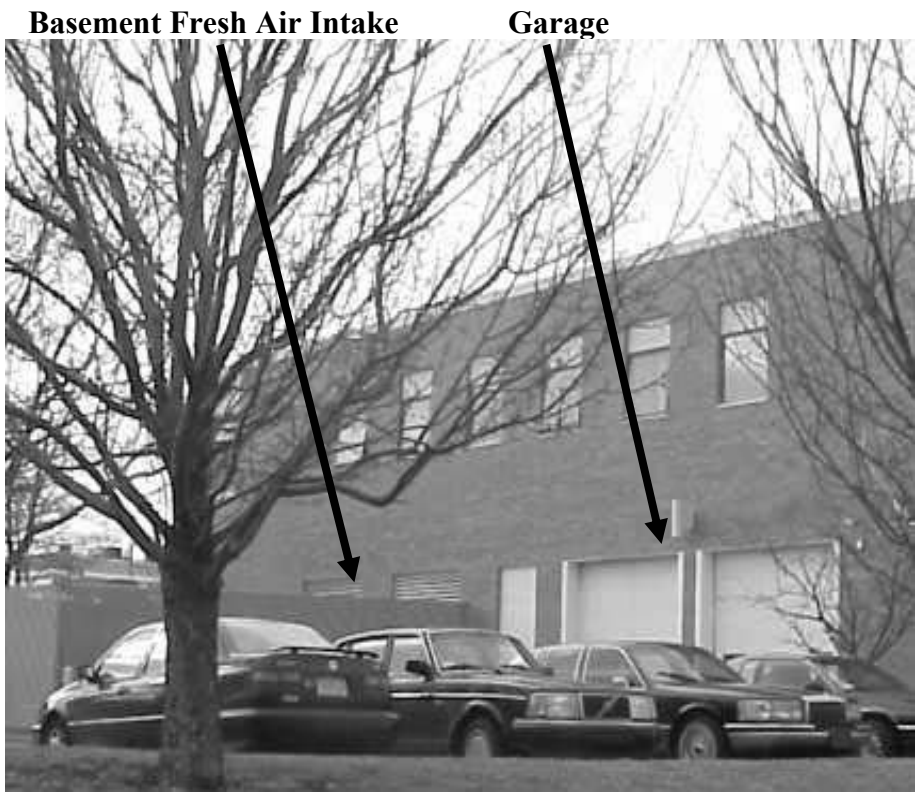
**Picture 15**

The fresh air intake for the basement AHU is located within a cyclone fence enclosure next to the garage door (see Picture 15). The fresh air intake is connected to the AHU that provides air for the vault in the clerk's office. Sheriff's vans were noted parked next to the cyclone fence. It is possible that idling vans can produce exhaust that can be entrained and distributed to the interior of the building by the basement AHU. M.G.L. chapter 90 section 16A prohibits the unnecessary operation of the engine of a motor vehicle for a foreseeable time in excess of five minutes (MGL, 1986).

**Position of Basement AHU Fresh Air Intakes to Garage**

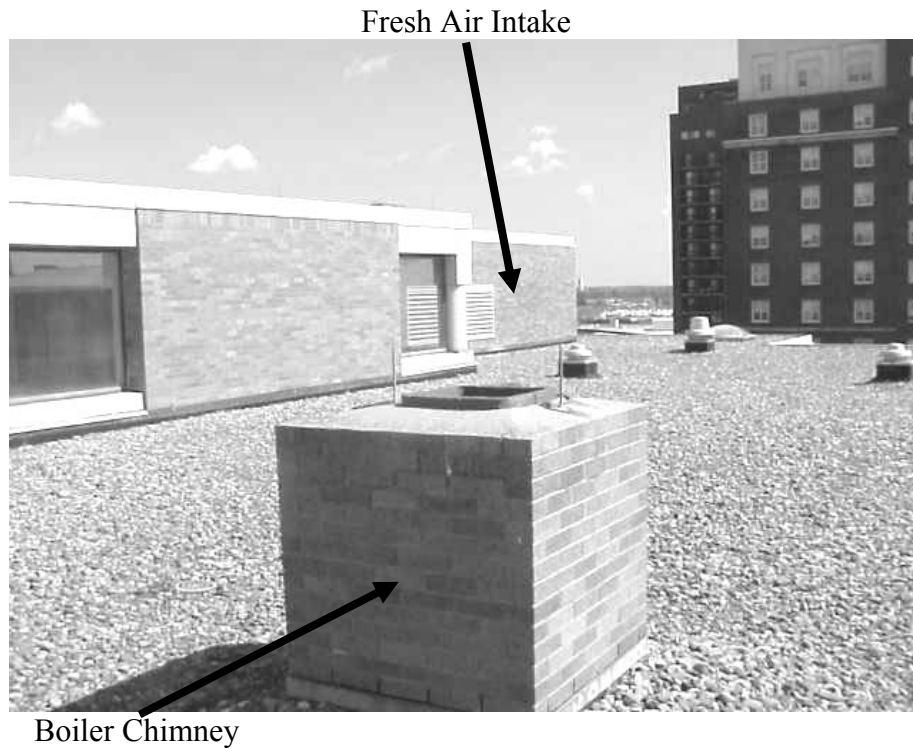
**Picture 1**

**Boiler Chimney Southwest of Fresh Air Intake**

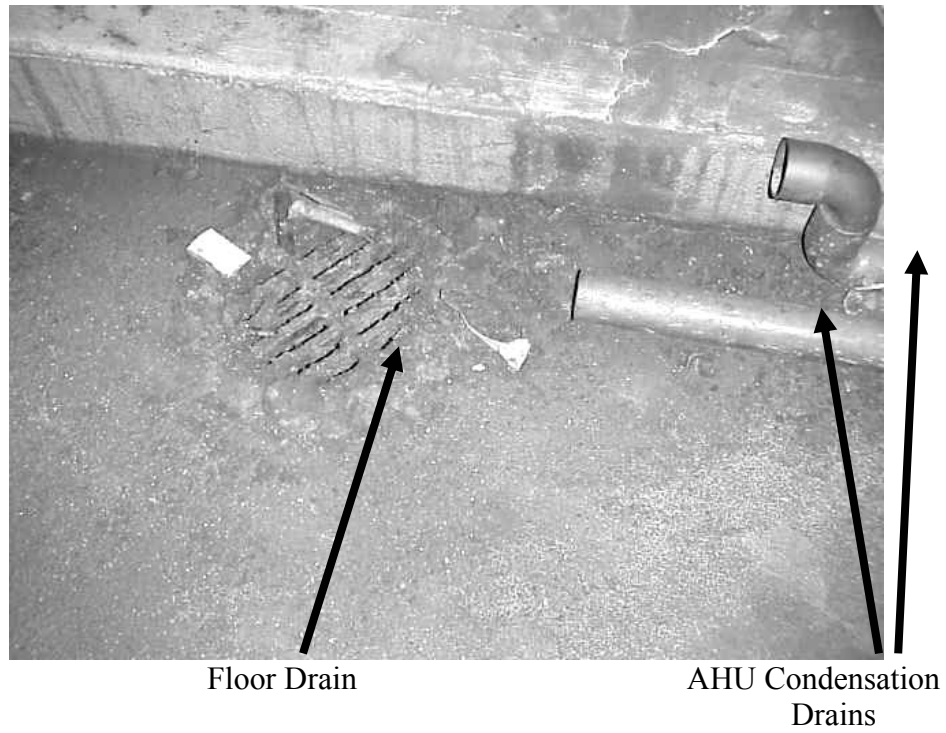
**Picture 2**

The final possible pathway involves the building ventilation system. This building has two rooms in a penthouse/attic that contain the air handling units (AHUs). The southern attic room contains the AHUs that service courtroom 1, courtroom 3, the lock up area and adult clerk's office. The courthouse AHUs are equipped to provide air-conditioning during warm weather months. AHUs that provide air-conditioning require the installation of condensation drains to prevent water build up inside the casing and ductwork. The condensation drains for these units terminate above a floor drain that is connected to the building drainage system (see Picture 2).

During this assessment, the AHUs were found to be drawing air through the condensation drains. This condition occurs because no water is produced by the AHUs during the heating season to create a watertight seal in the condensation drain. With each condensation drain acting as a vacuum, odors from floor drains without water-sealed traps can be drawn into the AHUs and distributed to occupied areas within the building.

**AHU Drainpipes That Terminate over Floor Drain**

1. Seal the floor drain in the garage.
2. Ensure water is poured into the AHU floor drains every other day to maintain the integrity of the traps.
3. Seal the condensation drains for AHUs during the heating season. Please note that these drains must be unsealed during the air-conditioning season in order to drain condensation. Failure to remove condensation drains seals can result in water back up into AHUs and produce mold growth.
4. Seal holes around utility pipes in the ceiling of the garage. Render wall seams or other breaches in the walls and ceiling airtight.
5. Consider extending the height of the chimney several feet above the top height of the AHU fresh air intake that is northeast of the chimney.
6. Consider installing exhaust ventilation for the garage.
